Engineering News-Record

Two Committees Report on the Knickerbocker Theater Collapse

Volume 88 — NEW YORK, MARCH 30, 1922 — Number 13

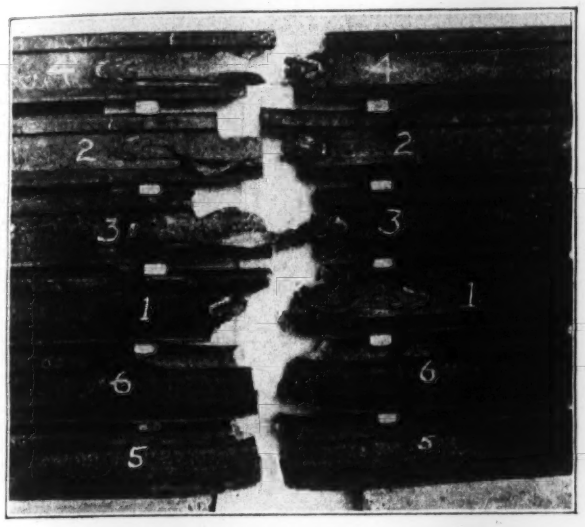
FIG. 2. DROP-TEST FRACTURES OF BONDED AND UNBONDED RAIL

Quite abnormal shapes of fracture resulted in the case of the bonded specimens, moreover. Fig. 2 here-

with, showing two unbonded and four bonded specimens, illustrates this point.

It was concluded from these tests that "serious injury is done to a rail by the welding process applied to its web," and the welded bonds therefore were not adopted

for use. A form of bond passing under the splice and attached to head or base of the rail by welding may be adopted, however, as welding to the more massive parts of the section is not believed to injure the rail.

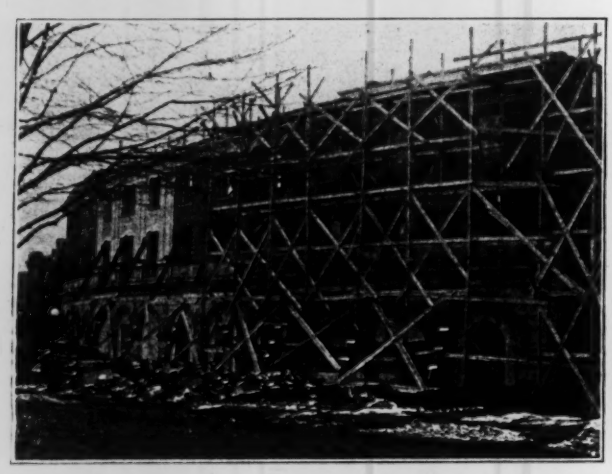
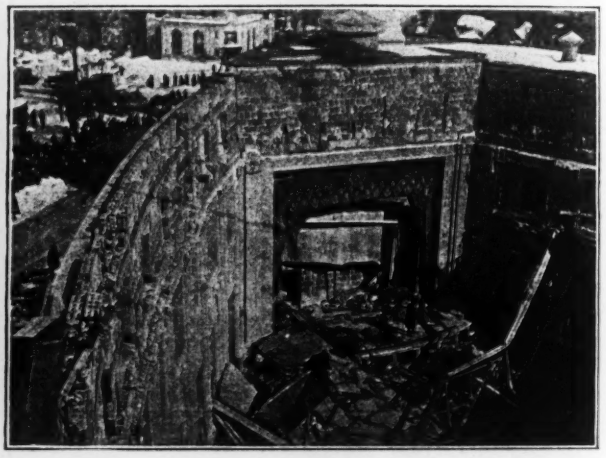
FIG. 1. KNICKERBOCKER THEATER: WALL CONSTRUCTION CRITICISED BY CONTRACTORS' COMMITTEE

Curved bearing wall on Columbia Road side of auditorium. This wall was cut up by many window openings, intended for exterior effect. At the light-colored portion of the wall the main roof truss was seated, bringing to bear a concentrated load of more than 50 tons. The wall at this point was found 5 in. out of plumb after the accident.

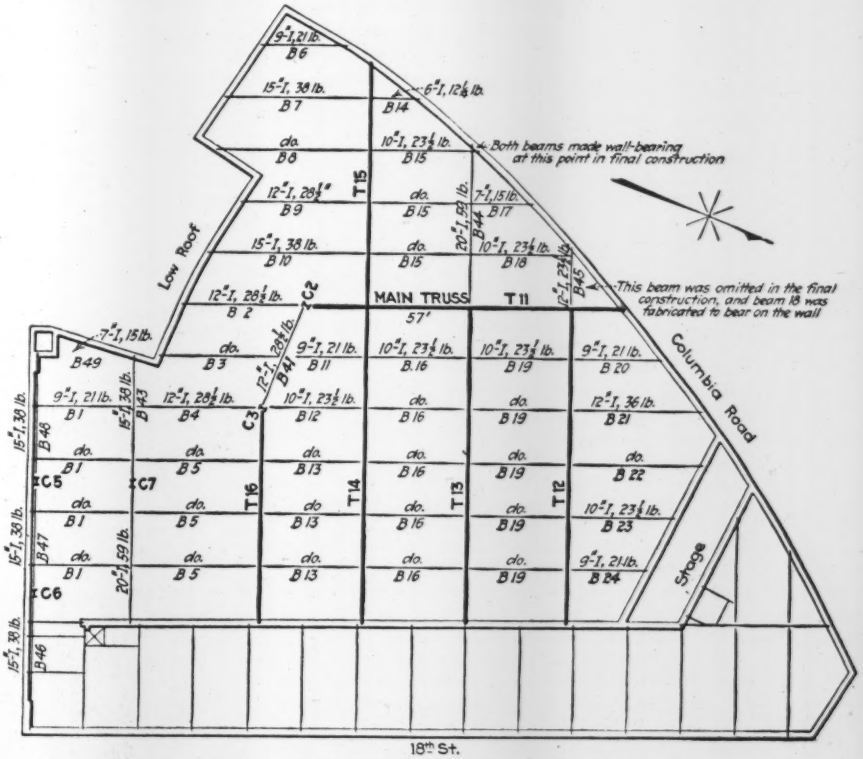
FIG. 2. KNICKERBOCKER ROOF FRAMING

Various engineers have charged the failure to bending or buckling of beam 41, between column C2 and C3, to failure of the wall seat of beam 21 pulling beam 22 off its seat with the result that truss T12 buckled, and to breaking of the roof slab between beams 21 and 22 with the same result. The A. A. E. and A. G. C. reports find that the main truss, T11, failed at its wall end and twisted off its seat, due to defective design.

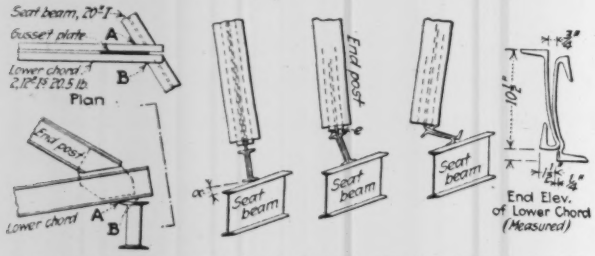
FIG. 3. DISTORTION CONDITIONS AT COLUMBIA ROAD (NORTH) END OF MAIN TRUSS T11

just how great was the inclination of the channels. However, with a deflection of the truss of 1 in., the inclination of the bottom chord channels would cause a bending of the gusset plate producing an eccentricity e of nearly 0.1 in., under which the sum of the computed direct and bending stresses would be close to the yield of the steel. From independent sources, statements from workmen have been reported that after erection there was a deflection of the truss T11 of 3 or 4 in. The eccentricity e presumably would be proportional to the deflection of the truss, and the significance of such a deflection will be apparent. Under such critical conditions any other influence tending to increase the eccentricity would be almost certain to result in crippling of the gusset and lower chord of the truss. As it

Sketched by A. A. E. Committee. The deflected position of the truss on its seating beam in the wall is sketched at the left to exaggerated scale. Following this, the deduced sequence of distortion is indicated. Sketch at right shows the present condition of the north end of the bottom chord.

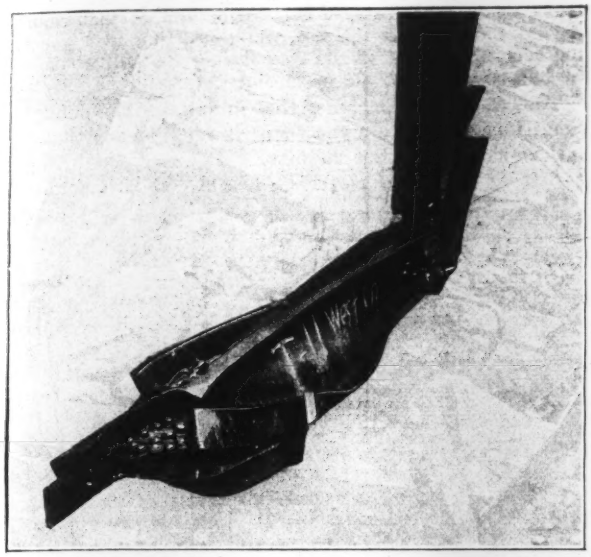
FIG. 5. TWISTED NORTH END OF BOTTOM CHORD OF MAIN TRUSS

The end piece of the truss has been placed in a vertical position, indicated by the web members at the first panel point. The end of the chord in the foreground is twisted more than 90 degrees, with its top flange forced down eastward. The ends of the 12-in. channels, which had no connection or staying for 8 in. from the end, carried a load of 55 tons when the truss was in service.

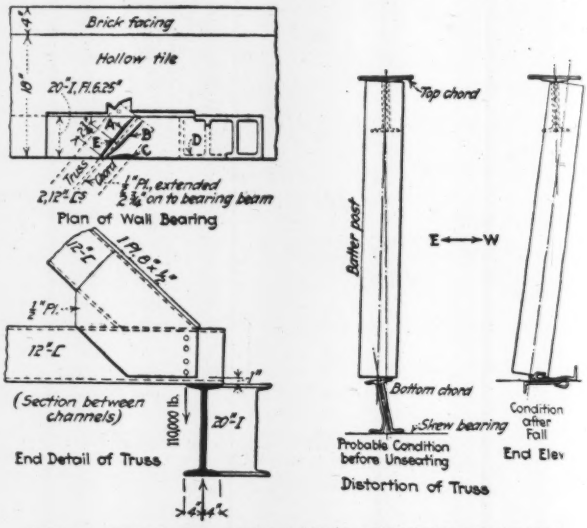
FIG. 7. WALL BEARING AND DISTORTION OF MAIN TRUSS (A. G. C. REPORT)

The weakness of the upper gusset, connecting the batter post to top chord, is strongly emphasized by the contractors' committee.
